**Kitsap County Health District
Upper Hood Canal Pollution Identification and Correction Project
Final Report**

Leslie Banigan, R.S.
Pollution Identification and Correction Program
December 31, 2008

Funded by Washington State Department of Ecology, Centennial Clean Water
Funds
and the Kitsap County Surface and Storm Water Management Program

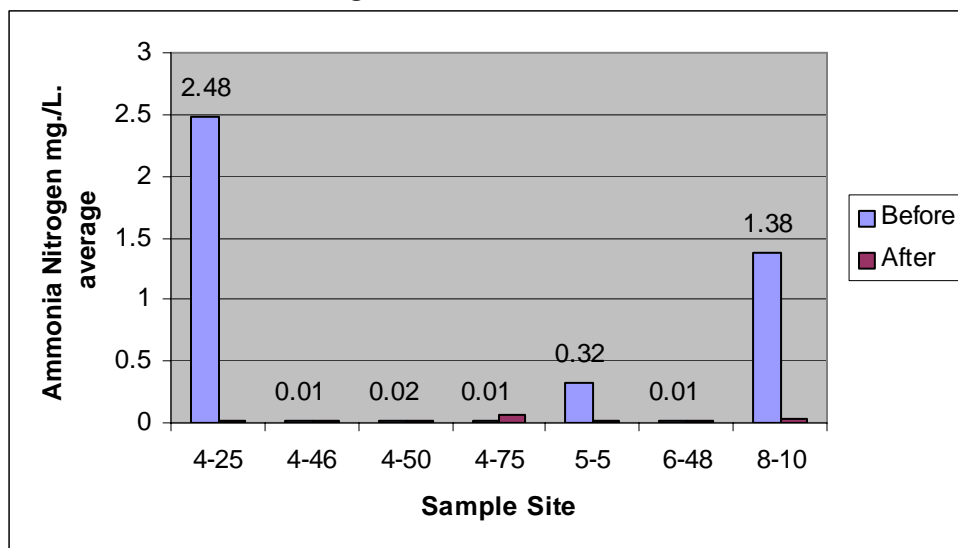
Table 7
Ammonia Nitrogen Before and After OSS Correction

Table 7 shows average ammonia nitrogen levels before and after OSS correction. Note the large decreases at sites 4-25 and 8-10, both direct discharges to the shoreline.

Statistically significant reductions were found at site: 5-5. Sites 4-25 and 8-10 showed significant reductions at the 90% confidence level. Elevated ammonia nitrogen levels found at site 5-5 indicate incomplete nitrification of the sewage effluent, which may be due to hydraulic overload, plugged drainfield, and 50-foot proximity to the shoreline. Elevated ortho-phosphate levels may be the result of hydraulic overload and 50-foot proximity of drainfield to the shoreline.
