**KITSAP PUBLIC HEALTH DISTRICT
ENVIRONMENTAL HEALTH DIVISION
POLLUTION IDENTIFICATION & CORRECTION PROGRAM**

**PORT ORCHARD PASSAGE RESTORATION PROJECT
FINAL REPORT**

**Lucas Jordan
Stuart Whitford
June 2013**

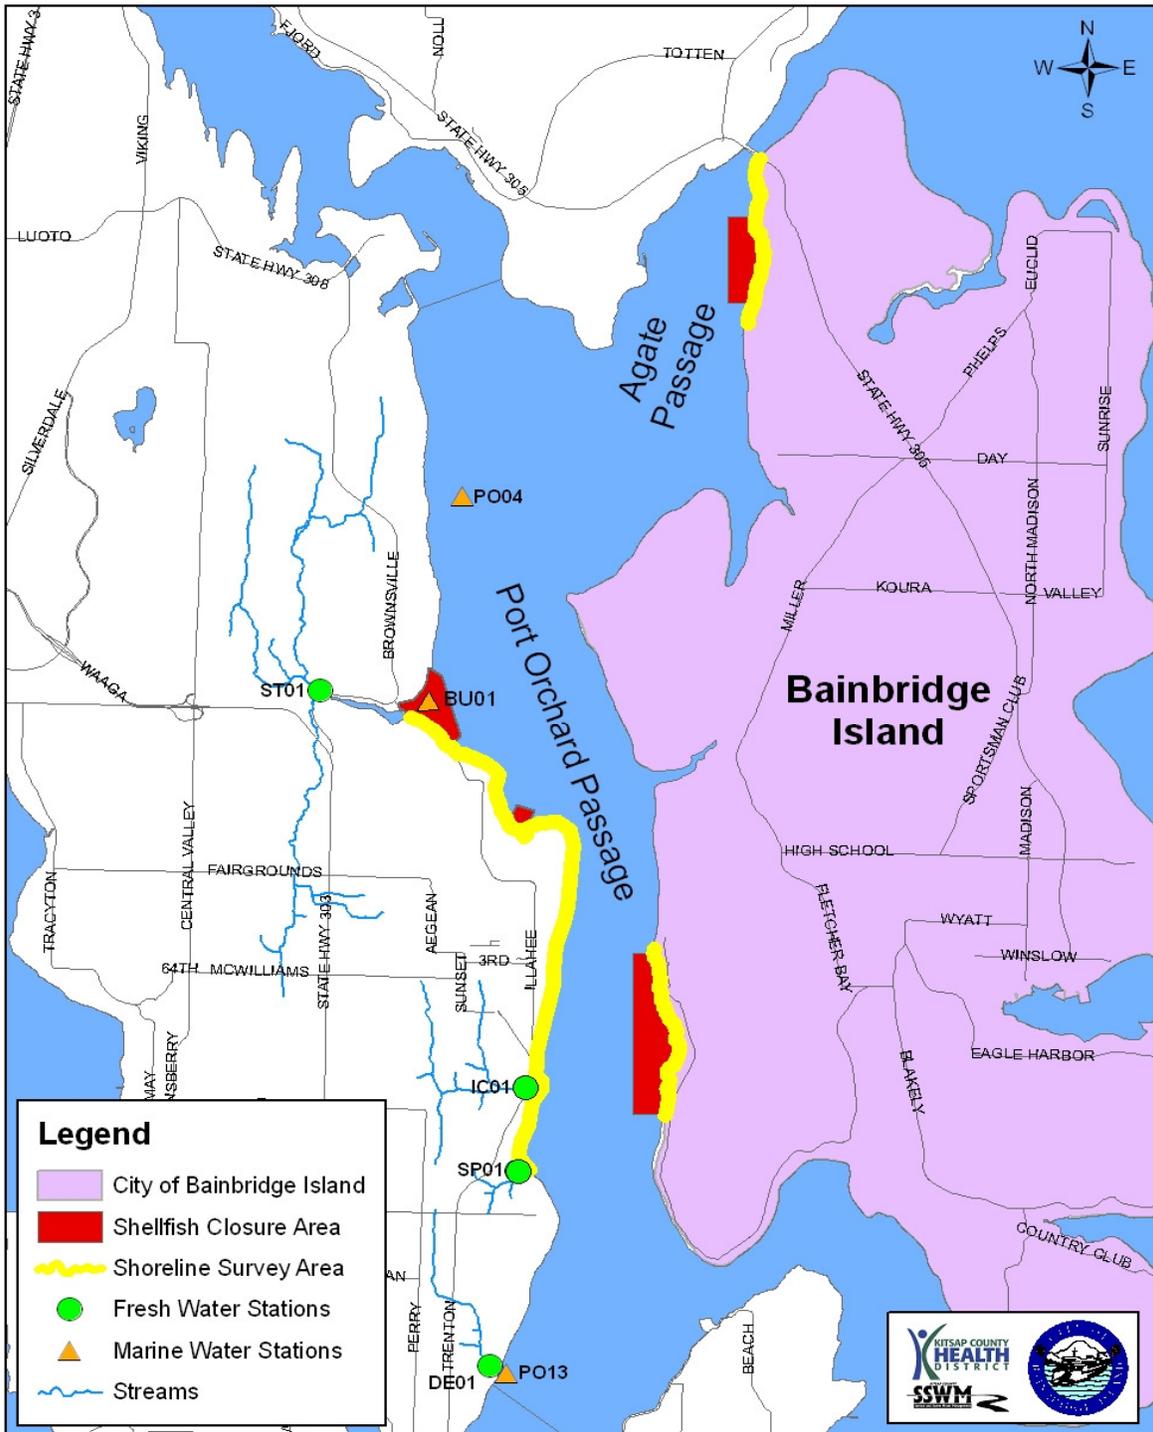
Figure 1
Port Orchard Passage Restoration Project Shoreline Areas

There are three major shoreline areas within the project area: Agate Pass, Crystal Springs, and University Point/Illahee. The Agate Pass and Crystal Springs sections are located immediately surrounding the prohibited commercial shellfish growing areas on the Western shores of Bainbridge Island. The University Point/Illahee section is located on the Eastern Shore of Port Orchard Passage between Steele Creek and the Illahee State Park. The Port Orchard Passage Restoration Project area is mapped in **Figure 1** below:

The core activity completed by the Health District to achieve project goals and outcomes was marine shoreline surveys in the areas described in Figures 1, 4, 5 and 6. Wet season shoreline surveys were performed in April 2011 and February 2012, and dry season shoreline surveys were performed in June 2011 and June 2012. All three sections of shoreline, totaling 7 miles, were sampled during each survey. Wet season shoreline surveys screen for OSS that fail due to surface or groundwater intrusion. Dry season surveys can identify failures masked by dilution during the wet season.

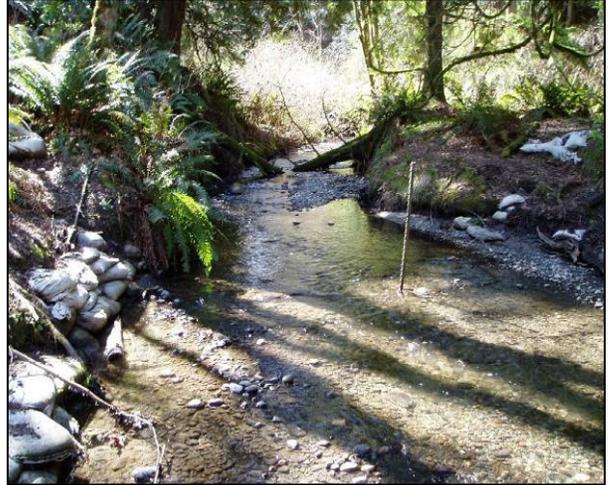
Steele Creek monitoring station ST01
near Brownsville

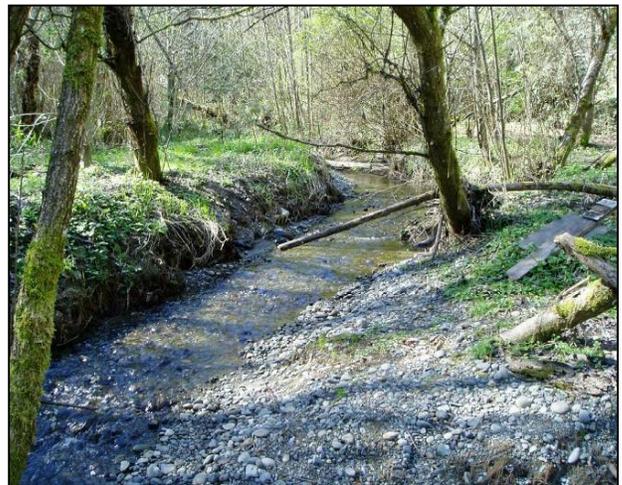
Illahee Creek monitoring station IC01

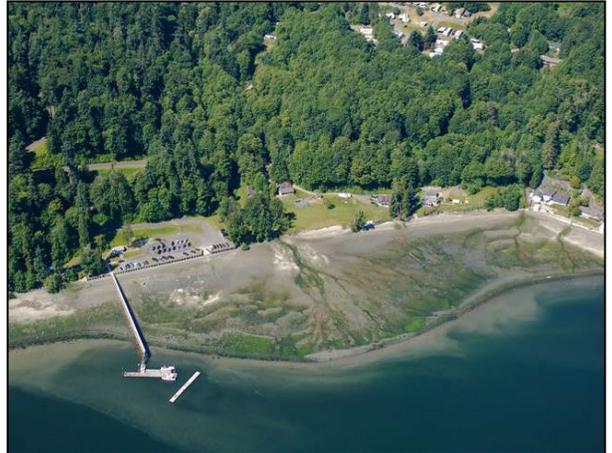
Illahee State Park Creek where it flows into Port Orchard Bay

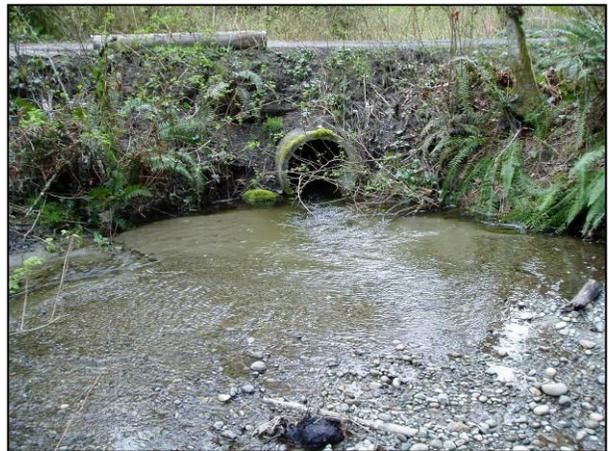
Station DE01 downstream of Enetai Beach Road

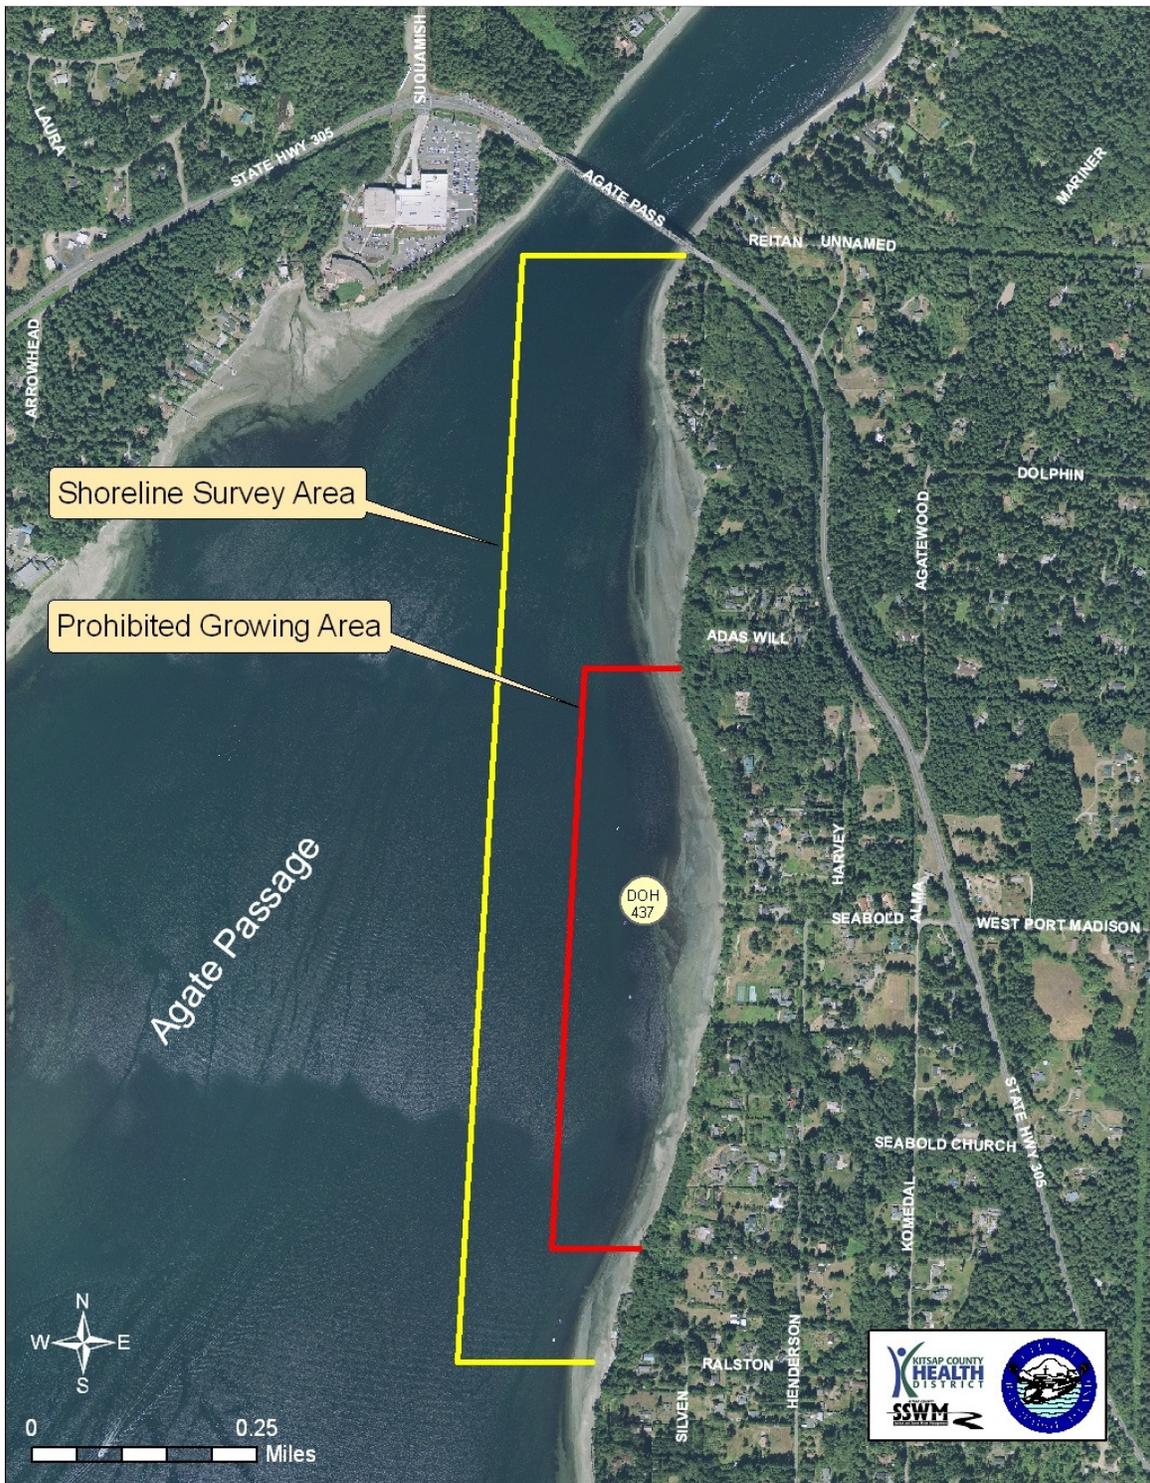
Figure 4. Agate Passage Shoreline Survey Area

134 initial samples at **46** unique sampling stations were collected in the Agate Pass shoreline section during the project. **Five (5)** FC "hot spots" were identified in this area. No failing oss were identified in proximity to these FC "hot spots".

Two of the hotspots appear to be directly attributed to a very high density raccoon population within the drainages. The Health District found that one property owner had been daily feeding a population of raccoons, between 30 and 60 raccoons, which led to this abnormally high density of raccoons in the vicinity. We have observed multiple raccoon latrines located within the drainage, leading to the high fecal coliform bacteria levels in the basin.

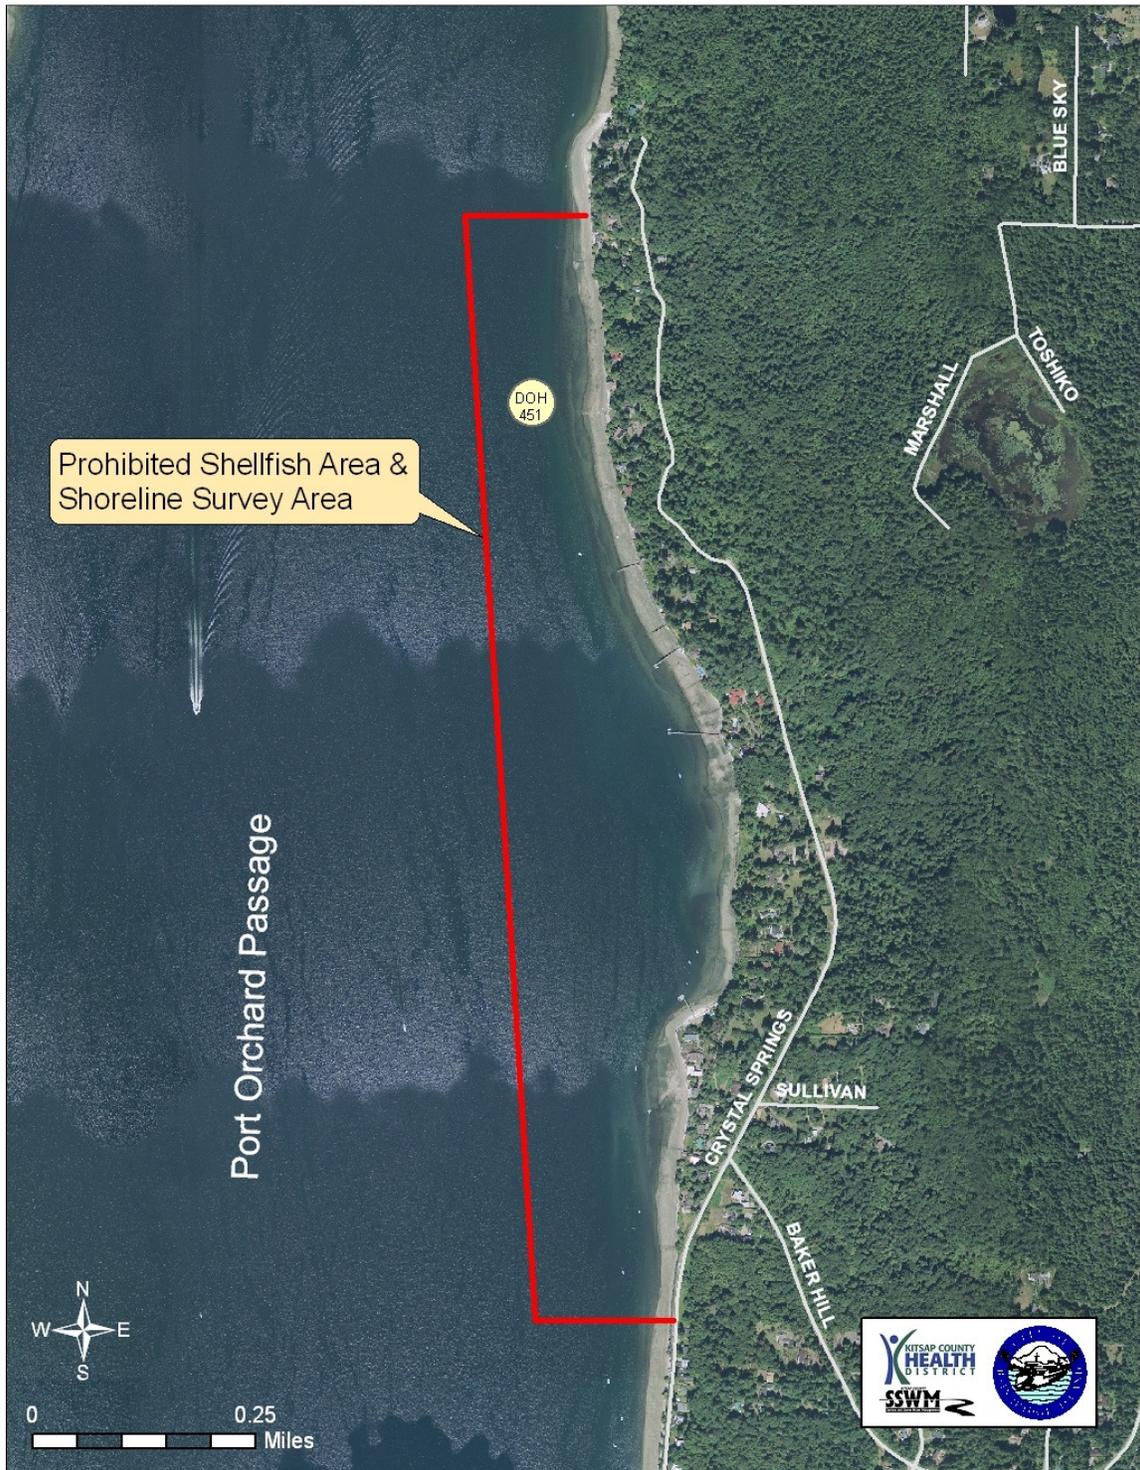
Figure 5. Crystal Springs Shoreline Survey Area

157 initial samples at **47** unique sampling stations were collected in the Crystal Springs shoreline section during the project. **Seven (7)** FC “hot spots” were identified in this area. Two failing OSS were found in proximity to one of the hotspots; both are scheduled for repair during the 2013 dry season.

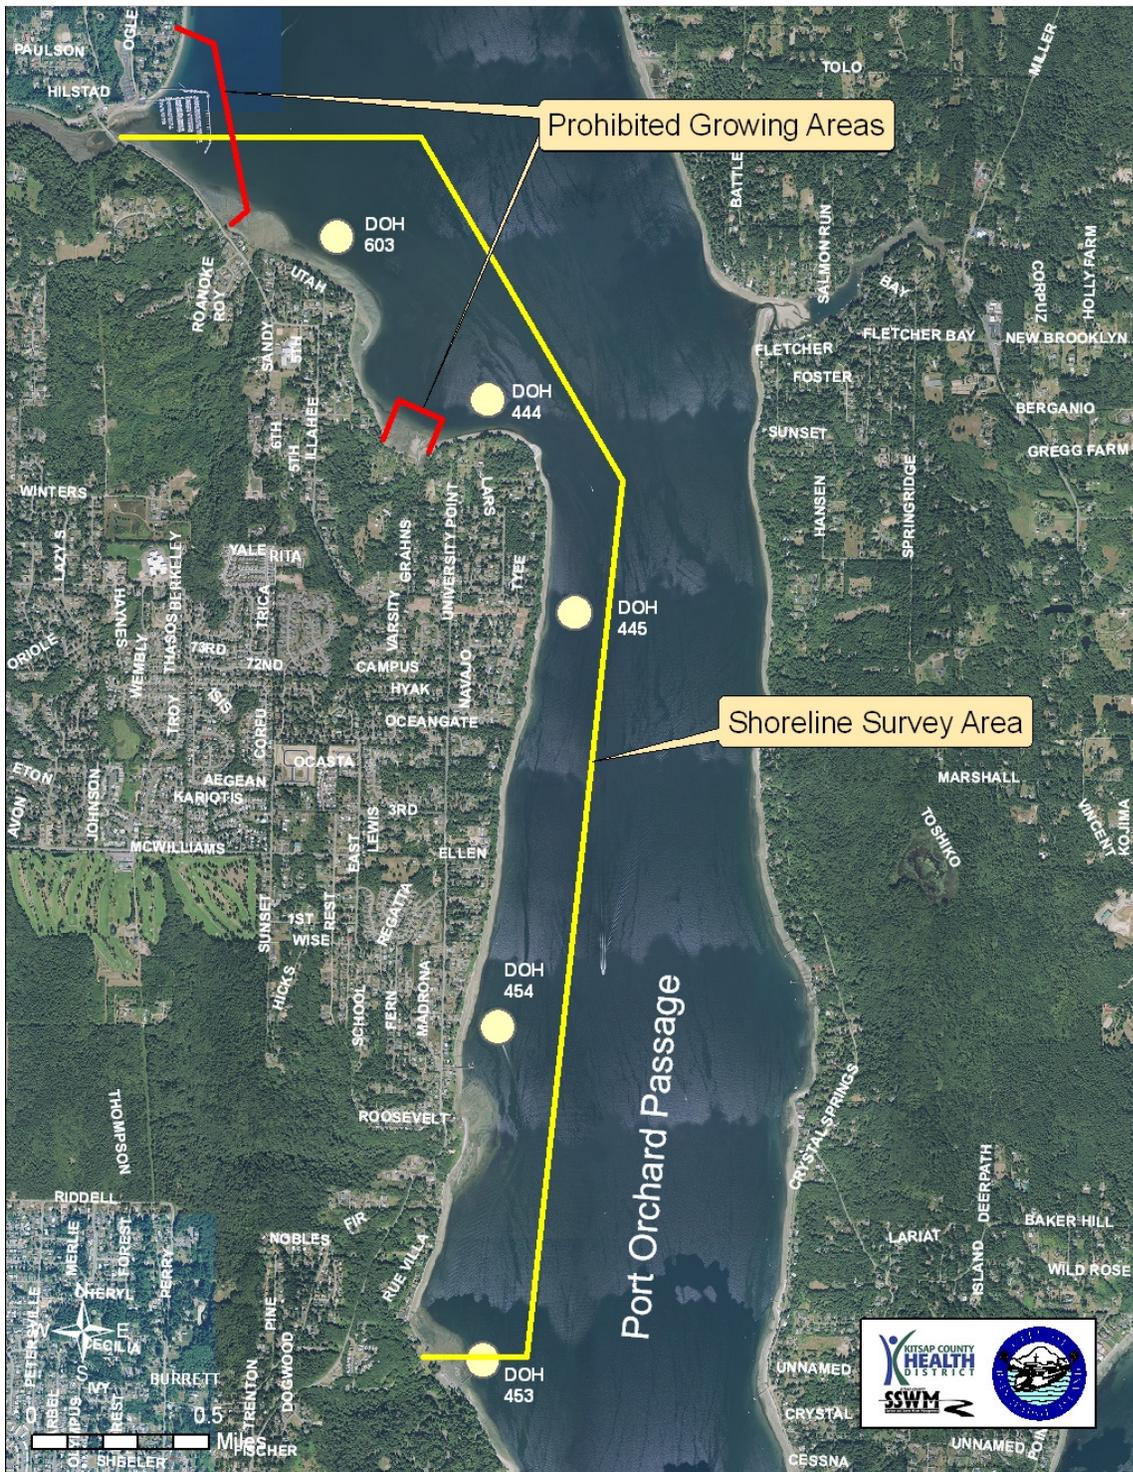
Figure 6. University Point / Illahee

334 initial samples at **112** unique sampling stations were collected in University Point / Illahee shoreline section during the project. **Eleven (11)** FC hot spots were identified in this area. Failing OSS were found at two of the hotspots. All three failing oss will be repaired by July 2013. No FC sources were identified in the remaining hotspots.

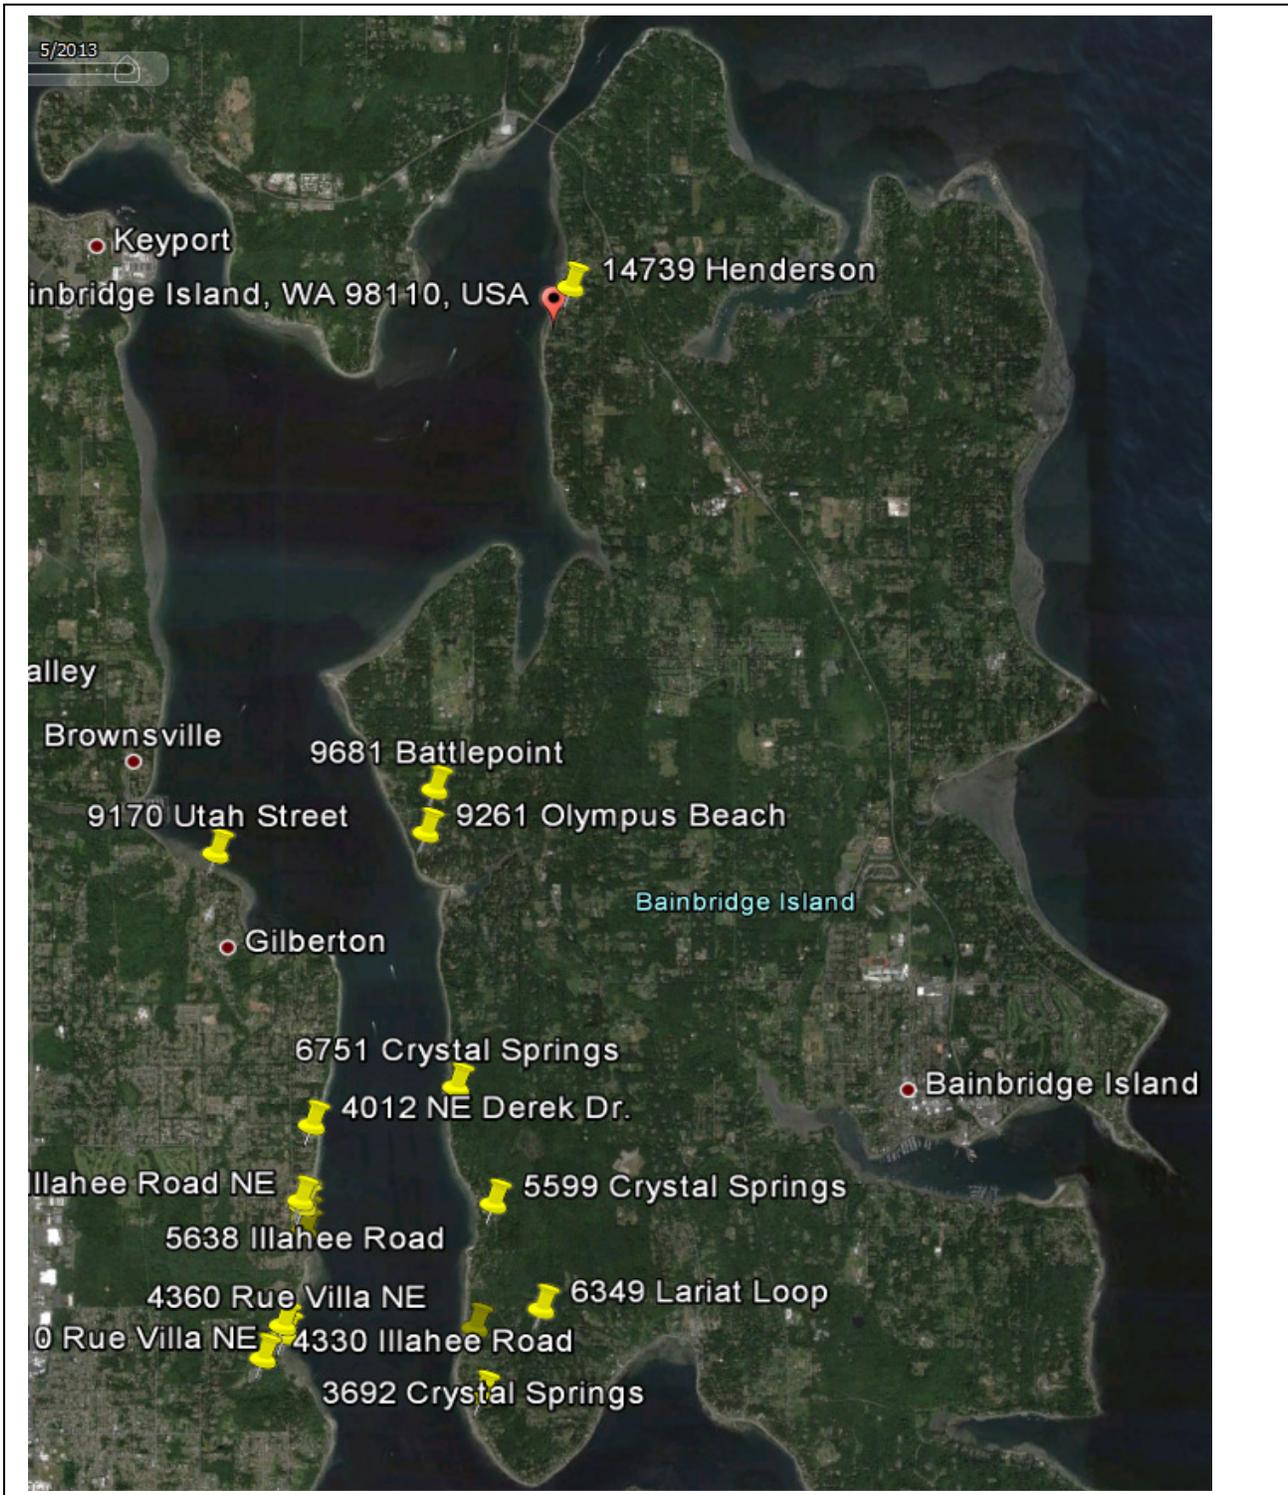
Figure7. Location of OSS Failures

Of the **18** failures identified during the project the most common identifying characteristic was sewage coming to the surface of the ground from the OSS. **Table 6** displays the types of failures observed during the project.

Figure 7 describes the location of the failing oss.

Ten (11) of eighteen (61%) failing OSS have been repaired: six (55%) were repaired with alternative on-site systems; five (45%) were repaired with minor repairs. The remaining seven (7) are in the repair process. All repairs should be completed by July 2013.

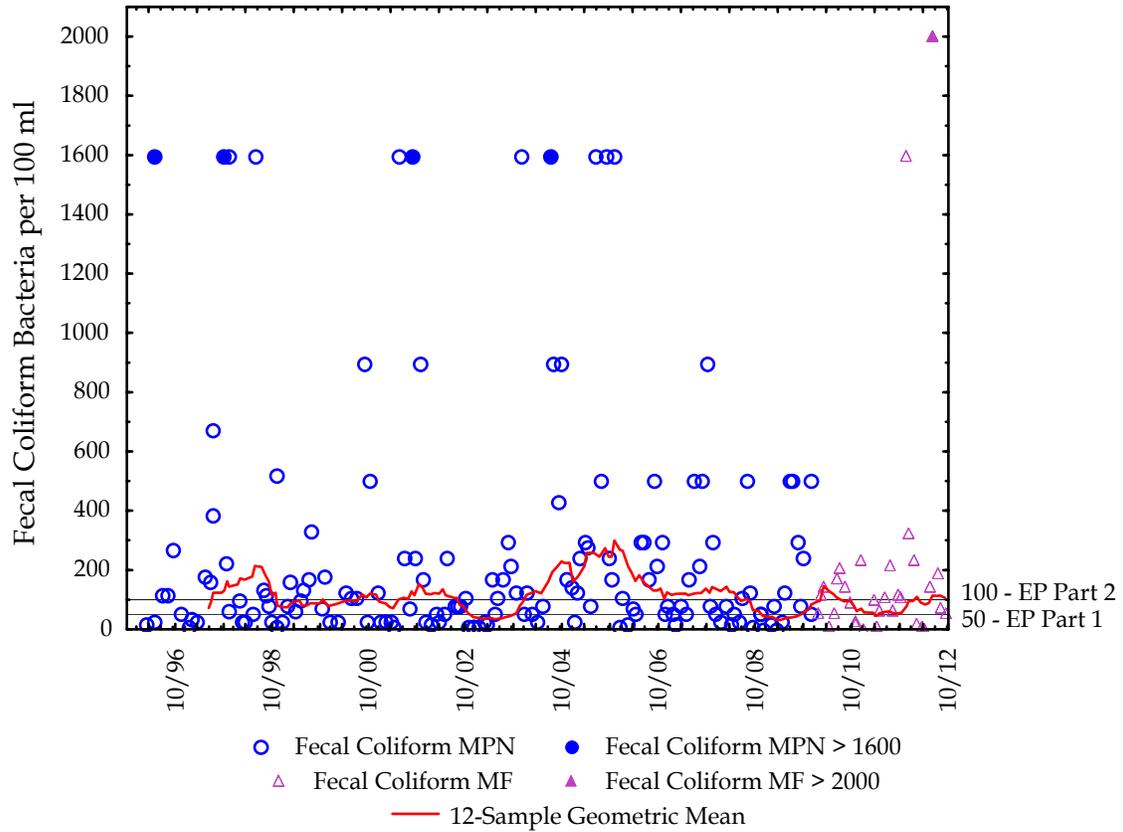
**Figure 8. Fecal Coliform Bacteria Trend Analysis
Steele Creek (Station ST01), 1996 - 2012**

The overall water quality of Steele Creek remains poor, and failed both parts of the freshwater Extraordinary Primary Use Category for the 2012 water year. Both the long term trend (5+ years) and the short term (3 year) trend remain stationary. No property surveys were conducted along this stream as that was outside the scope of the project.

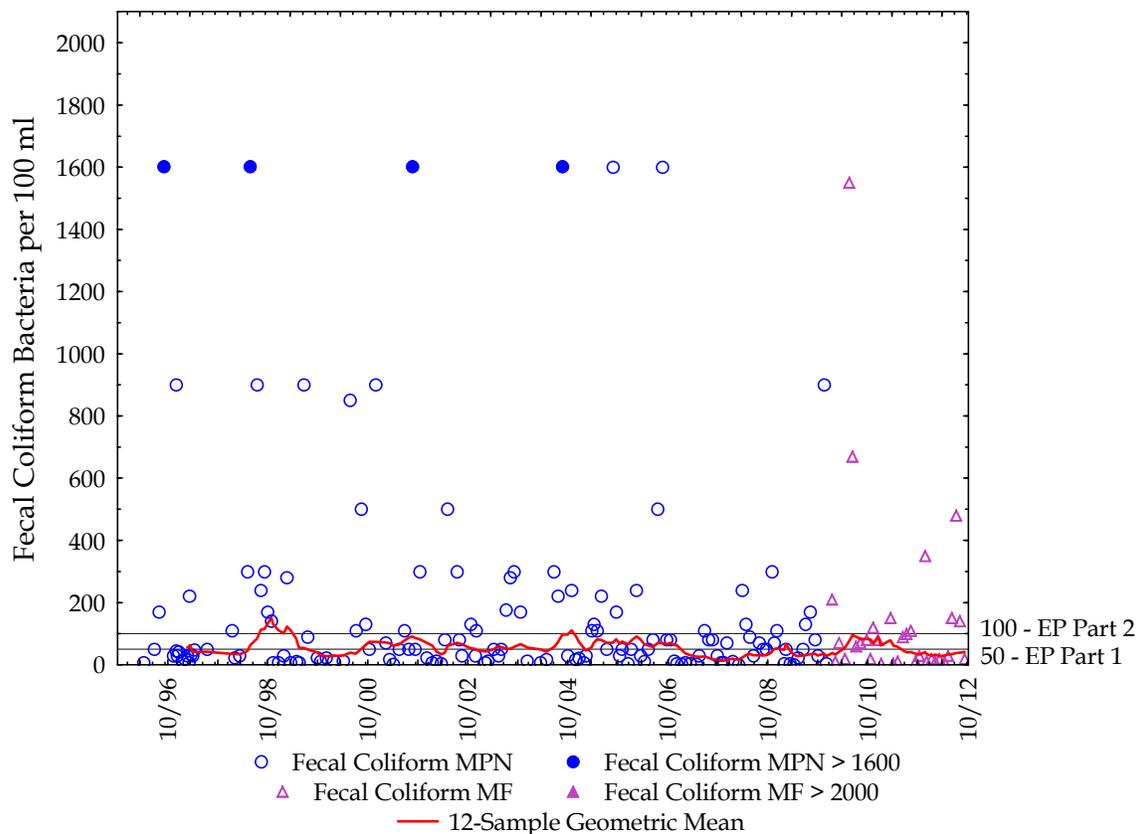
**Figure 10. Fecal Coliform Bacteria Trend Analysis
Illahee State Park Creek (Station SP01), 1996 - 2012**

Water Quality in Illahee State Park Creek is good with the long term trend (5+ years) shows that the creek is improving, while the short term (3 year) trend remains stationary. In 2012, the Illahee State Park Creek met Part 1 of the freshwater Extraordinary Primary Water Quality Standard, but failed Part 2 of the standard. No property surveys were conducted along this stream as that was outside the scope of the project.

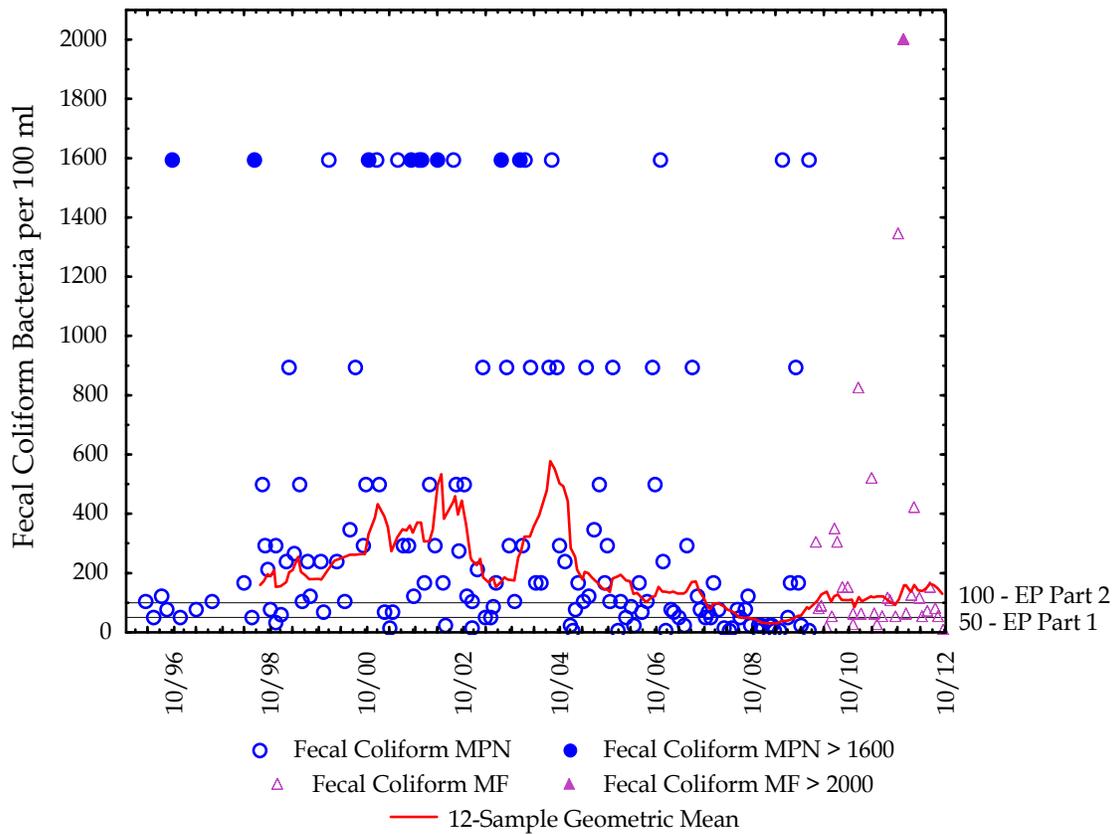
**Figure 11. Fecal Coliform Bacteria Trend Analysis
Enetai Creek (Station DE01), 1996 - 2012**

While the overall water quality of Enetai Creek remains poor, the long term trend (5+ years) shows that the creek is improving, while the short term (3 year) trend remains stationary. No property surveys were conducted along this stream as that was outside the scope of the project.

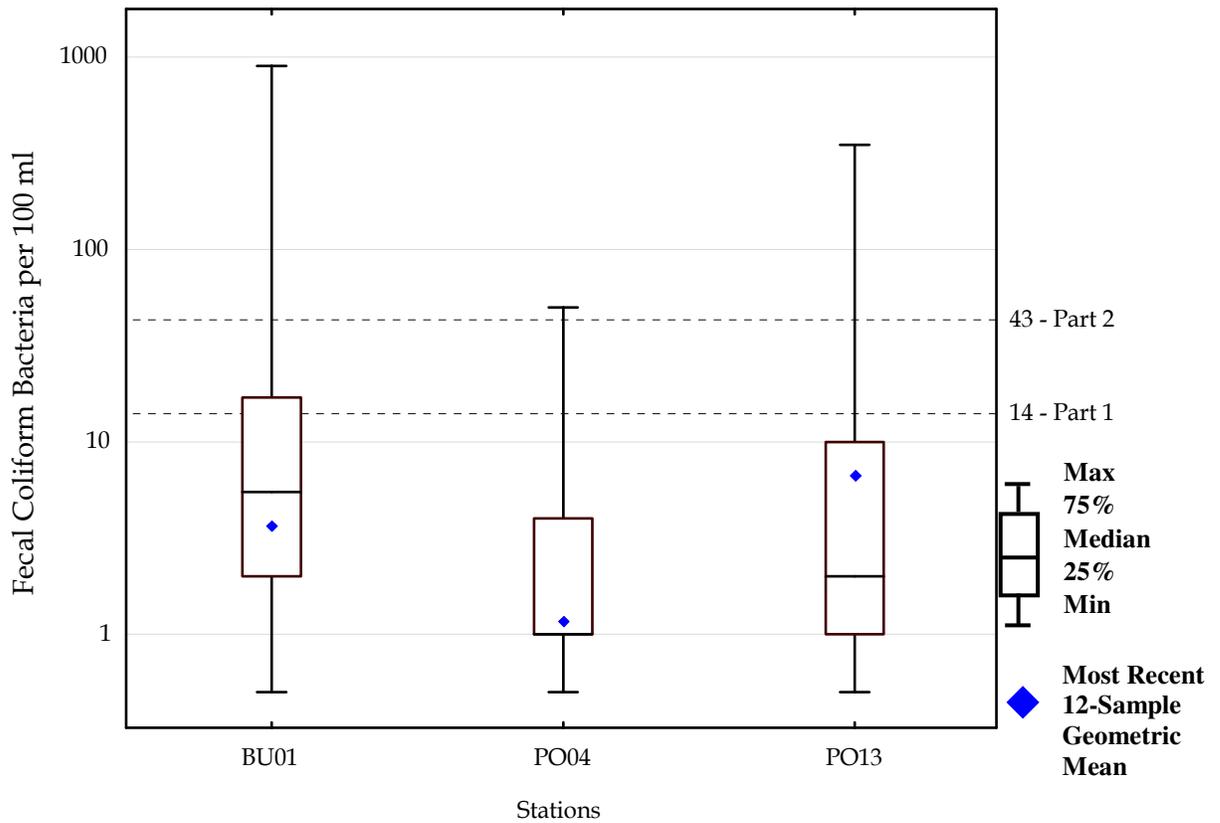
Figure 12. Port Orchard/Burke Bay Marine Water Summary 1996 – 2012

Port Orchard / Burke Bay marine waters are showing a significant improving global trend. One of the three individual sampling stations in the watershed (BU01) is showing significant, long-term improvement.
