KITSAP COUNTY HEALTH DISTRICT  
ENVIRONMENTAL HEALTH DIVISION  
WATER QUALITY PROGRAM

**YUKON HARBOR WATERSHED RESTORATION PROJECT**

**FINAL REPORT**

December 2006

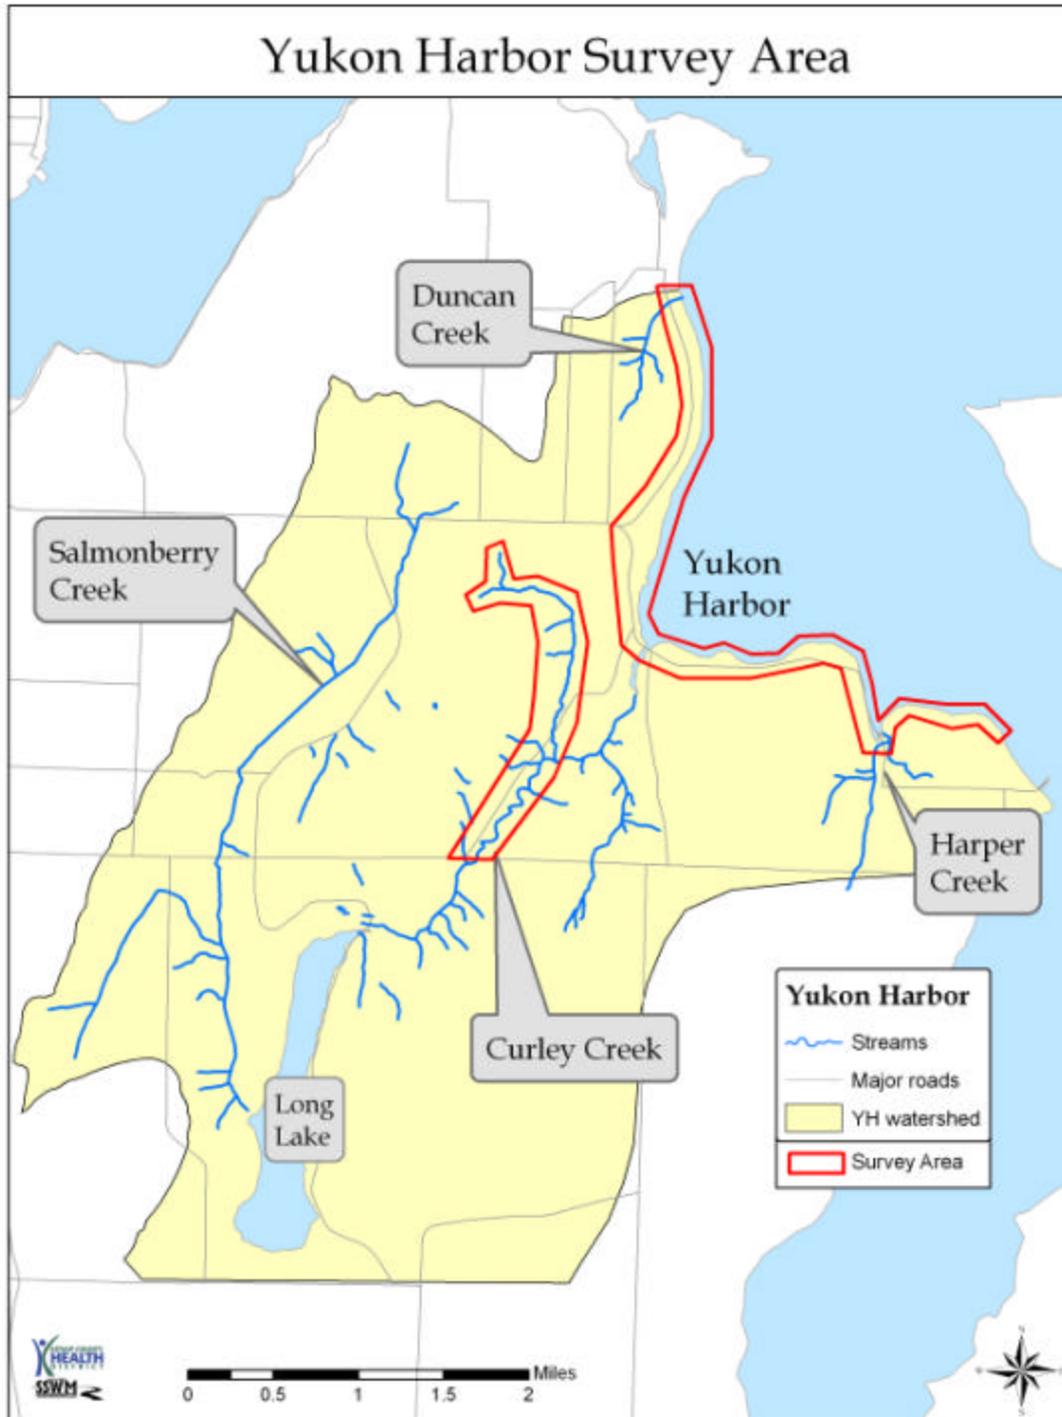
**Figure 1**

The Yukon Harbor Watershed Restoration Project became a cooperative effort of the Health District, Kitsap Conservation District (KCD), and the local community to conduct an intensive PIC survey of the Yukon Harbor marine shoreline and selected parcels along Curley Creek and Long Lake (see **Figure #1**). Funding was provided by a WSDOE Section 319 Non-Point Source Fund Grant, with matching funds from Kitsap County's Surface and Stormwater Management (SSWM) Program. This survey has been conducted in accordance with the Health District's comprehensive and proven "Manual of Protocol: Fecal Coliform Bacteria Pollution Identification and Correction Projects" (PIC Protocol). In addition, the Health District performed an assessment of FC impacts in the Salmonberry Creek watershed.

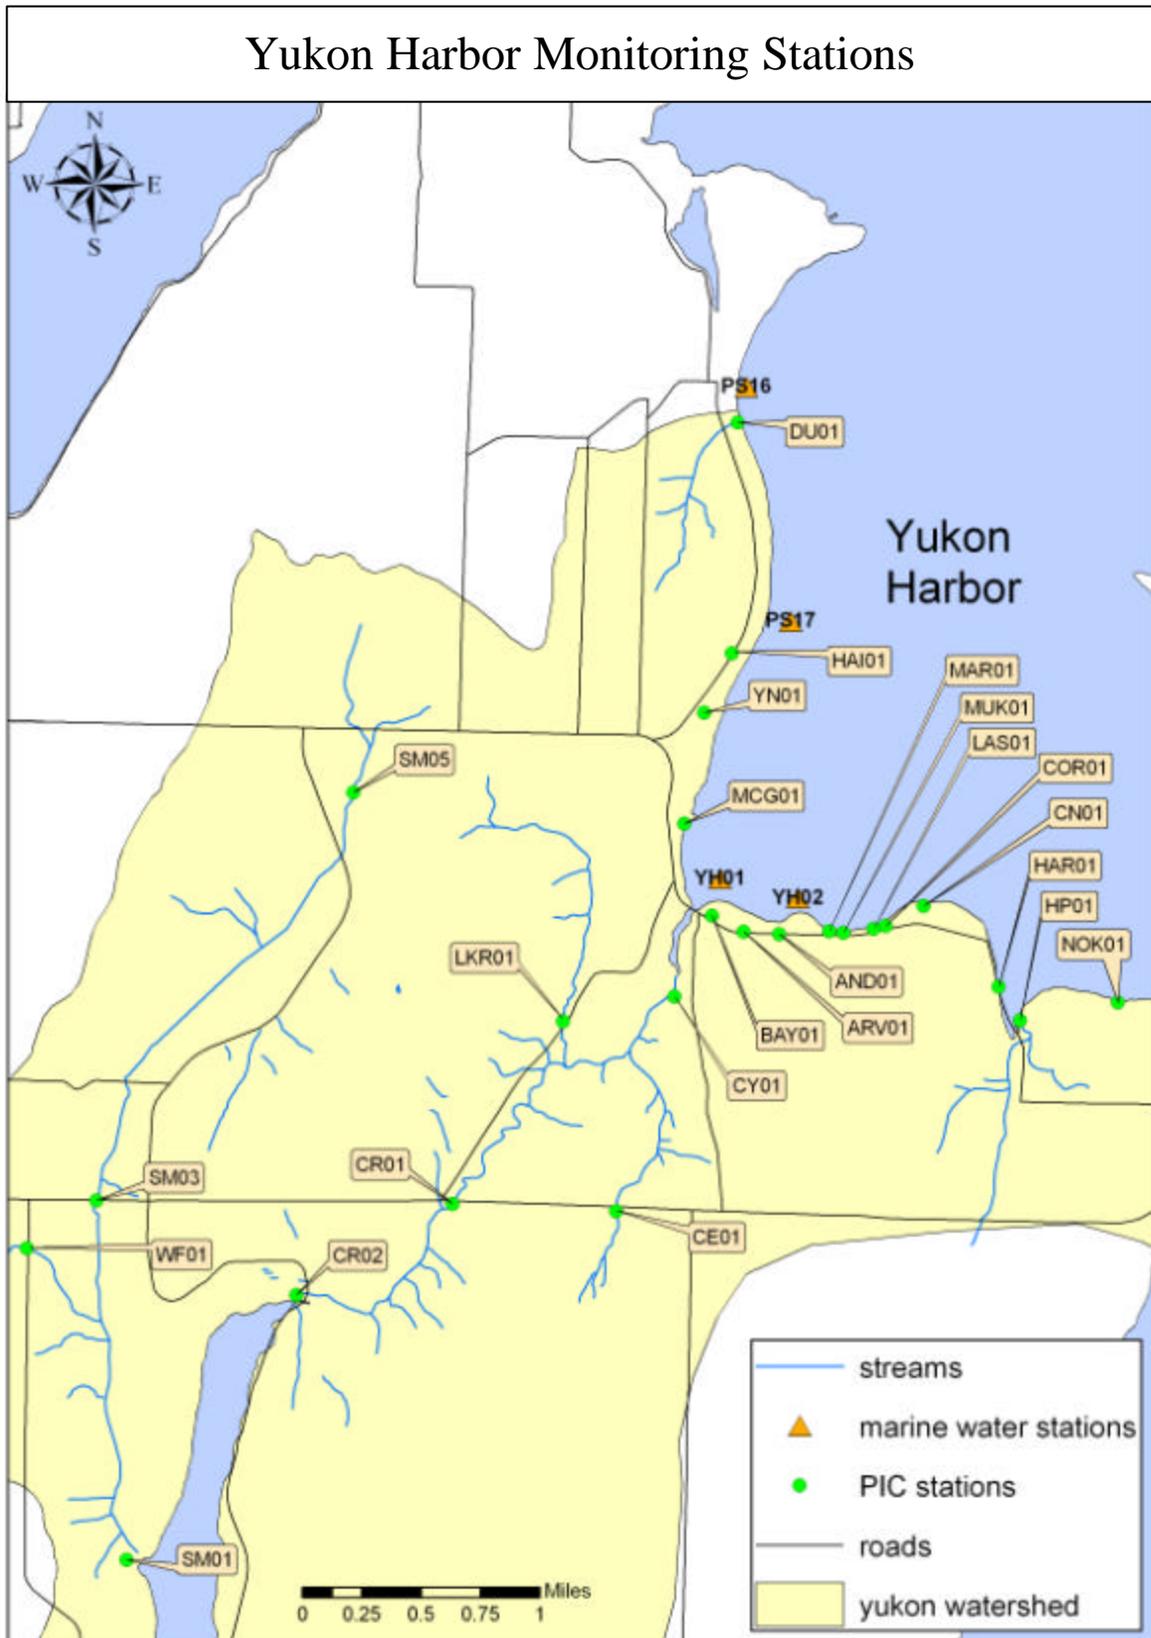
**Figure 3 Yukon Harbor Monitoring Station Map**

The purpose of Impact monitoring was to characterize FC water quality of watershed segments. Impact monitoring began with semi-monthly sampling of fourteen trend and seven impact monitoring stations in the project area. Additional impact stations were added during the project to facilitate source identification. Sample frequency was adjusted to monthly in 2004 to better utilize resources. Many investigative samples were added to Impact events to assist in FC source locations after water quality data located high FC counts in previous samples. These temporary additional samples were used to further segment streams to help with the FC source investigation and were not recorded in the water quality database. Impact monitoring has been conducted using the same field procedures as set forth for trend monitoring in the Trend Plan.

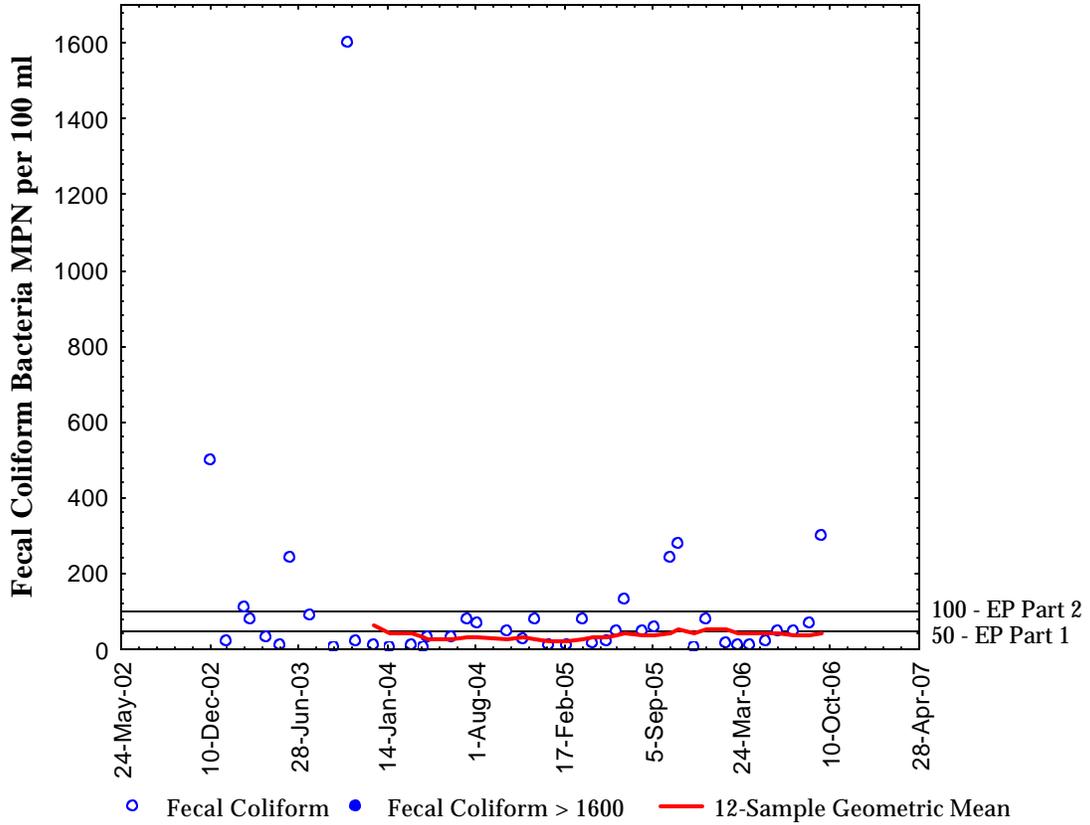
**Figure 4**

**Fecal Coliform Bacteria Trend Analysis  
Curley Creek (Station CY01), 1996 - 2006**

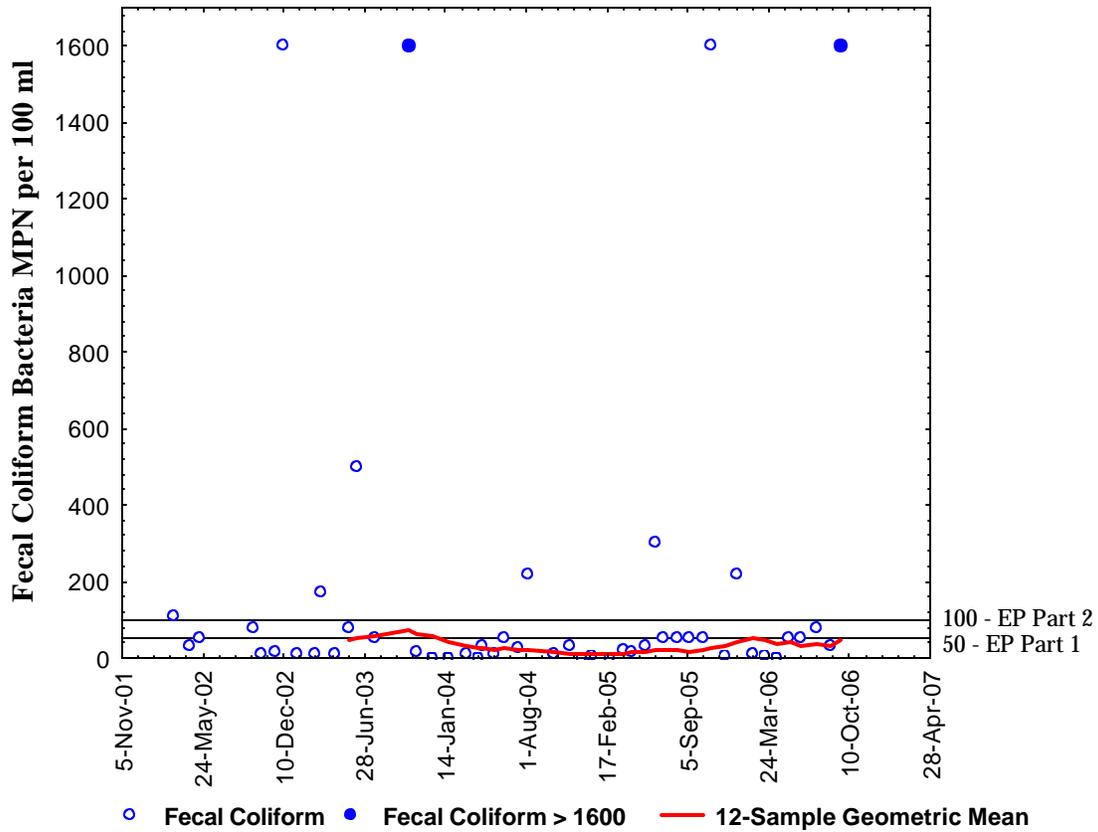
Figure 5

**Fecal Coliform Bacteria Trend Analysis  
Duncan Creek (Station DU01), 1996 - 2006**

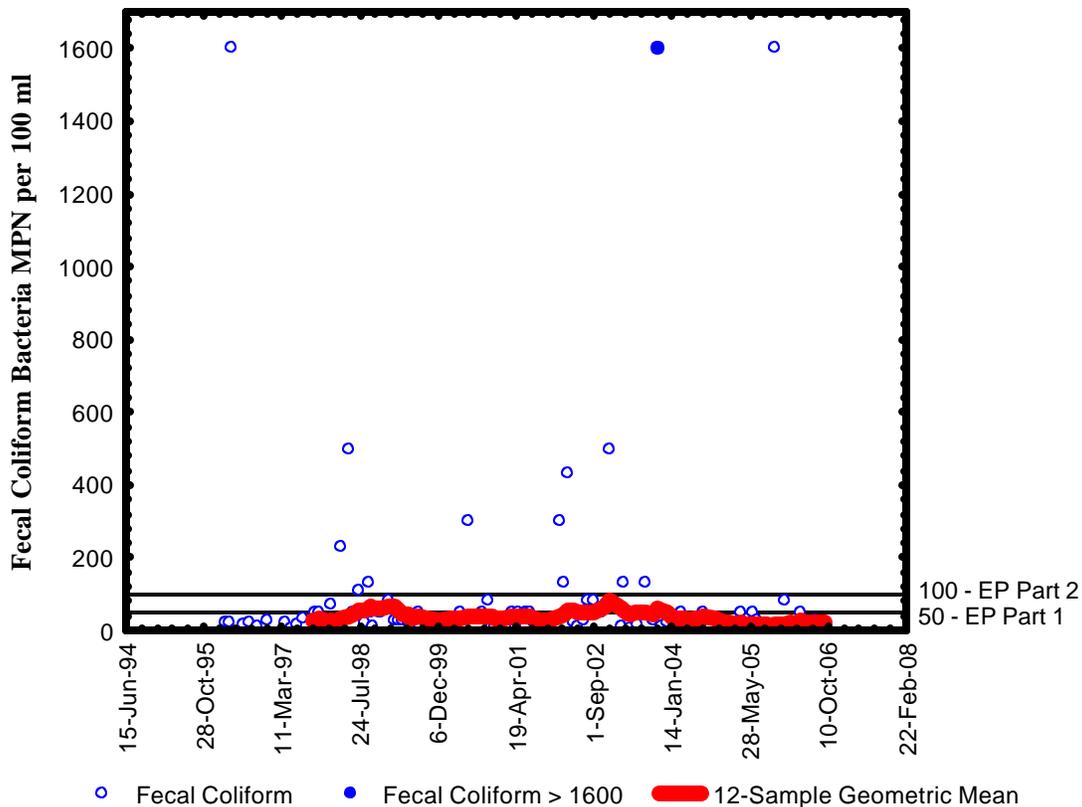
**Figure 6**

**Fecal Coliform Bacteria Trend Analysis  
 Salmonberry Creek (Station SM01), 1996 - 2006**

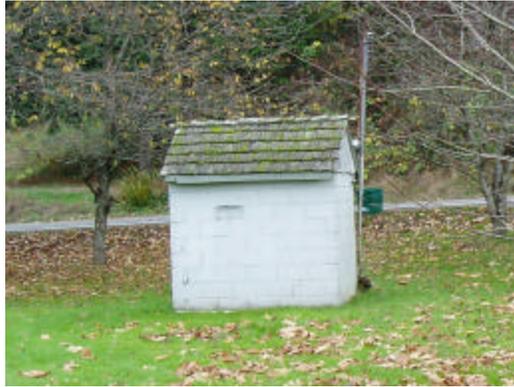
## Bliss Water System

The Bliss water system has not been approved for any connections but currently has four homes connected. The well is located on the upper southeast corner of the Bliss property. There are no drainfields located within the 100' arc. Four drainfields are within the 200' arc; these are all down gradient of the well with no problems discovered during the inspections. The Long Lake Manor well head is located 120" from the Bliss wellhead.

The system manager was informed of the dangers of excessive use of fertilizers and asked to not use any fertilizer near the wellhead. The drinking water program is aware of the non-conforming issues and has a hold on all county permit approvals until this system is in compliance.

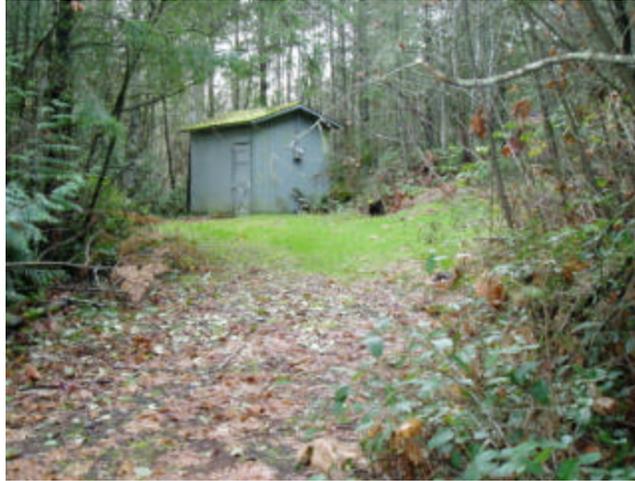
## Feddock Water

Located in the middle of a large undeveloped parcel, and serving the homes located down gradient on long narrow lakeside parcels. The Feddock well has no drainfields within the 100' or the 200' arc. Approved for all of the existing seven connections.

Education of the possible sources typically found for wells with high nitrate levels has been the action taken here. Mr. Feddock was given information to share with the homeowners sharing this well. We also asked them to continue with sampling and to watch for “risky” conditions near the wellhead.

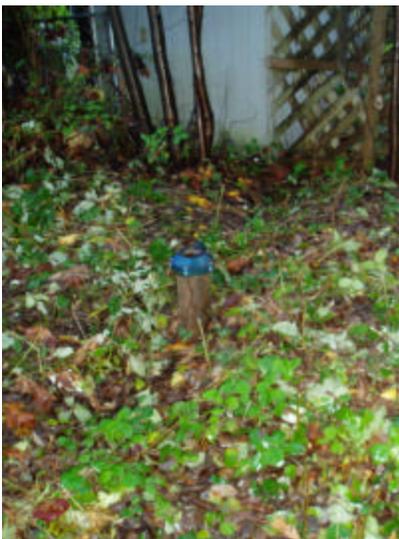
## Greenshore homeowners

Greenshore has connected to all of their allotted 10 connections. The wellhead is surrounded by the parcels it serves. The 100' arc is free from drainfields but the 200' arc has 9 drainfields located on all sides of the well. Several of the homes had minor issues with their drainfields yet none were failing. Both standard gravity and alternative systems are located within the 200' arc. One non-permitted drainfield, now abandoned, was located within 50' of the well and could have been a factor in the past. Recent nitrate samples are well below the action level.

Education and better septic system maintenance will be the action plan. Homeowners were encouraged to attend the septic system workshop and given homeowner manuals for septic systems.

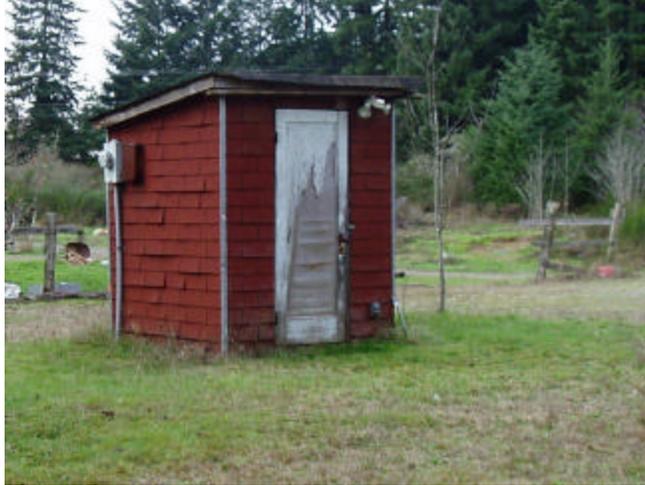
## Homer Wiley Water System

There are no drainfields within the 100' well arc. Five drainfields are located within the 200' well arc and all five passed inspection. This water system has struggled with improper management for some time. The new system managers are taking much better care than in the past.

The new owners of the well parcel have been informed of the past history, given instructions on the nitrate issues and asked to keep a close watch on the septic as they start to use it. The new system managers have been educated on nitrate issues and given brochures to share.

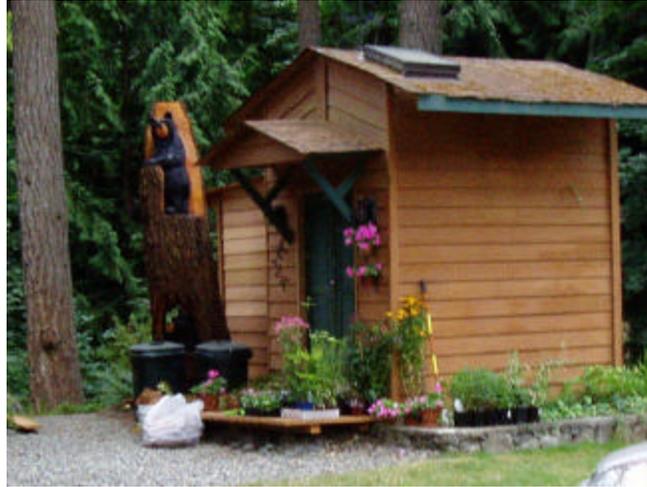
## John Cameron Water

The John Cameron well is located in the northwest corner of the Cameron property, overlooking a deep ravine to the west. Approved for four connections it currently has only three. The 100' well arc has no drainfields and the 200' arc has only one down gradient drainfield located at the south end of the Cameron property. This system has consistently high nitrate counts.

Mr. Cameron has been informed of the dangers of fertilizing his plants around the well and his heavy use of fertilizers on his lawn. His refusal to discontinue this practice may result in stronger corrective measures including a possible citation. This corrective action will continue beyond the close of the Yukon Project.

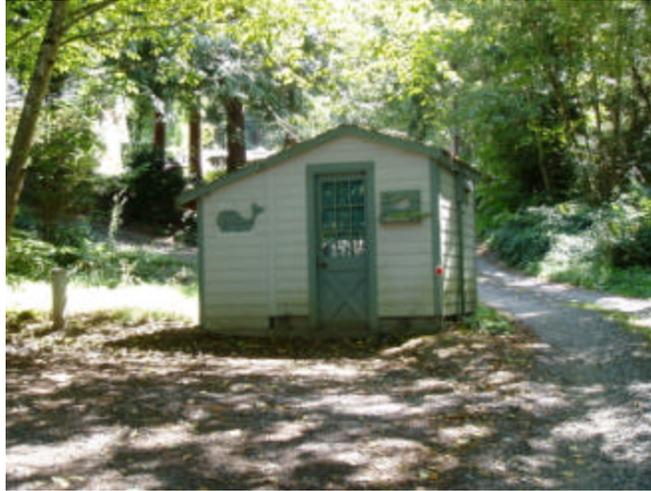
## King Road Water System

This system has four approved connections. There are no wells within a 150' well arc, with 4 drainfields within the 200' arc. All of the drainfields passed inspection, two of the drainfields are up gradient of the well and two are below it.

Education is the primary tool used here. There is no proof that the small greenhouse is contributing, and the cleared area, if part of the problem, will re-grow and promote nitrate uptake. The system manager was informed of the problem and advised to continue with frequent nitrate samples and to watch for signs of septic failures and over-greening in the neighboring lawns.

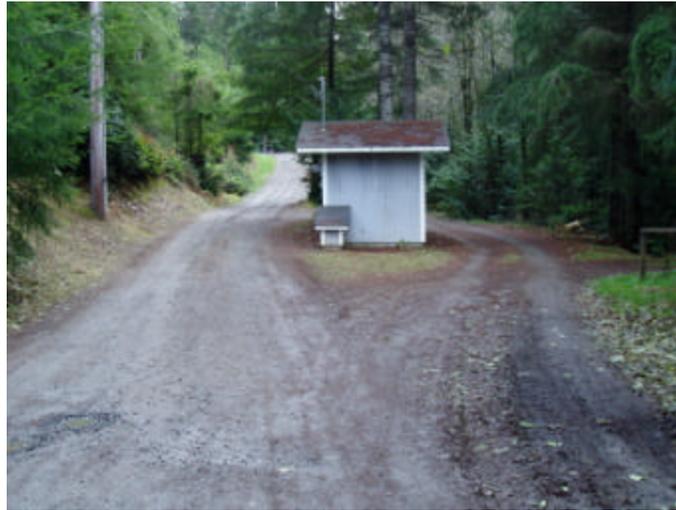
## King's Glen

This water system manager has denied access to the well by all county personnel. Several attempts to contact members of this system have failed. The system is not approved, with possibly seven to eight connections. The nitrate samples on file were submitted by the system manager and run by a state certified lab.

The drinking water program has put a hold on all county permit approvals for the parcels on this system. Before any parcel on this system can receive an approval for a permit the well system must first be in full compliance. Two of the homeowners have left the shared well system and received permission to drill private wells, these wells tested at <0.5 nitrate. The health District will continue to watch this system and consider stronger action including the possibility of a civil infraction.

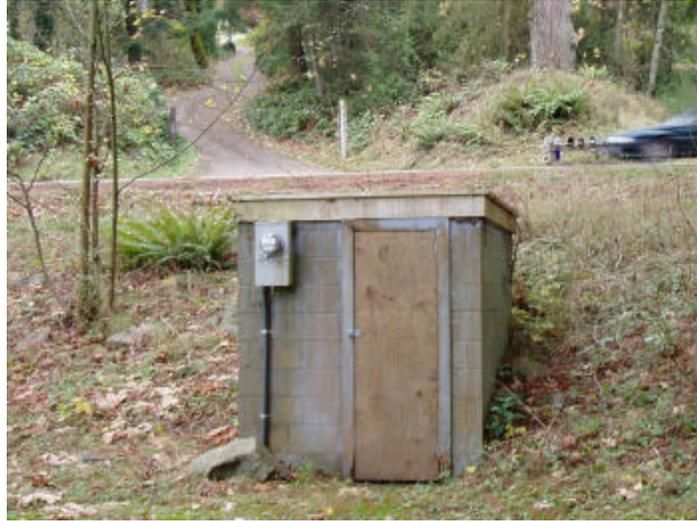
## Long Lake Manor Water

Approved for six connections this system is using only four of them. None of the drainfields are located within the 100' well arc. The 200' arc has only one down gradient drainfield within its boundaries, and it passed inspection. The Bliss Water system well is located 120' from the well.

The system manager was informed of the problem, given brochures to share and asked to watch over the area around the wellhead.

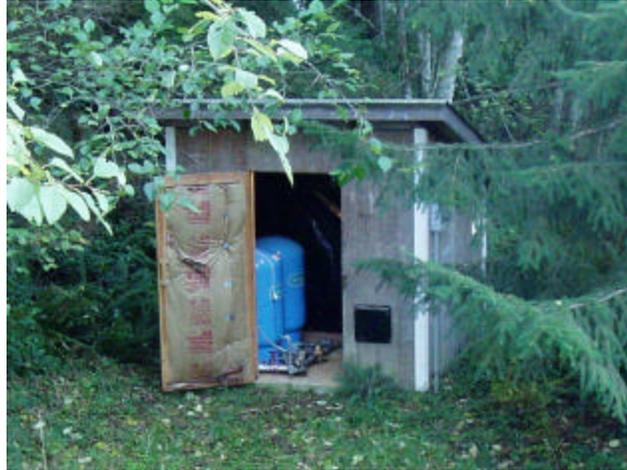
## Overra Road No. 1

The Overra system is using all seven of the approved connections. There are no drainfields within the 100' arc. The 200' arc has four drainfields and all four drainfields passed inspection.
