**KITSAP COUNTY HEALTH DISTRICT WATER QUALITY ANALYSIS OF
HOOD CANAL SHORELINE DISCHARGES PART 1**

1. INTRODUCTION AND BACKGROUND

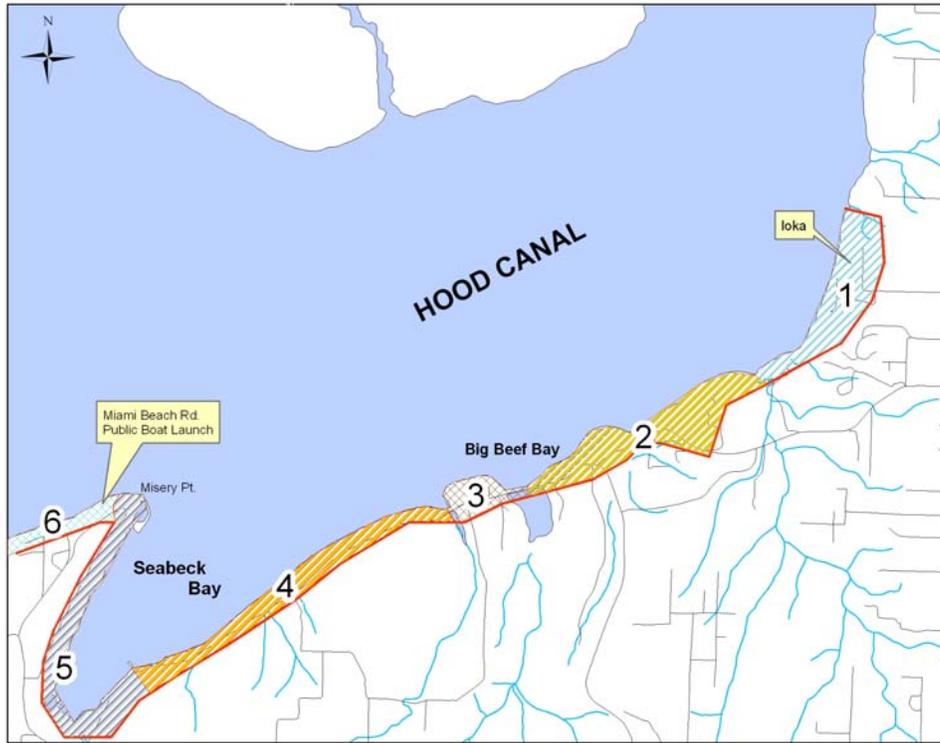
Figure 2. Kitsap Hood Canal Shoreline Survey Segments 1 through 6

Shaded areas denote developed shoreline areas, which were surveyed
