KITSAP COUNTY HEALTH DISTRICT
ENVIRONMENTAL HEALTH DIVISION
WATER QUALITY PROGRAM

DOGFISH CREEK RESTORATION PROJECT

FINAL REPORT

January 31, 2004

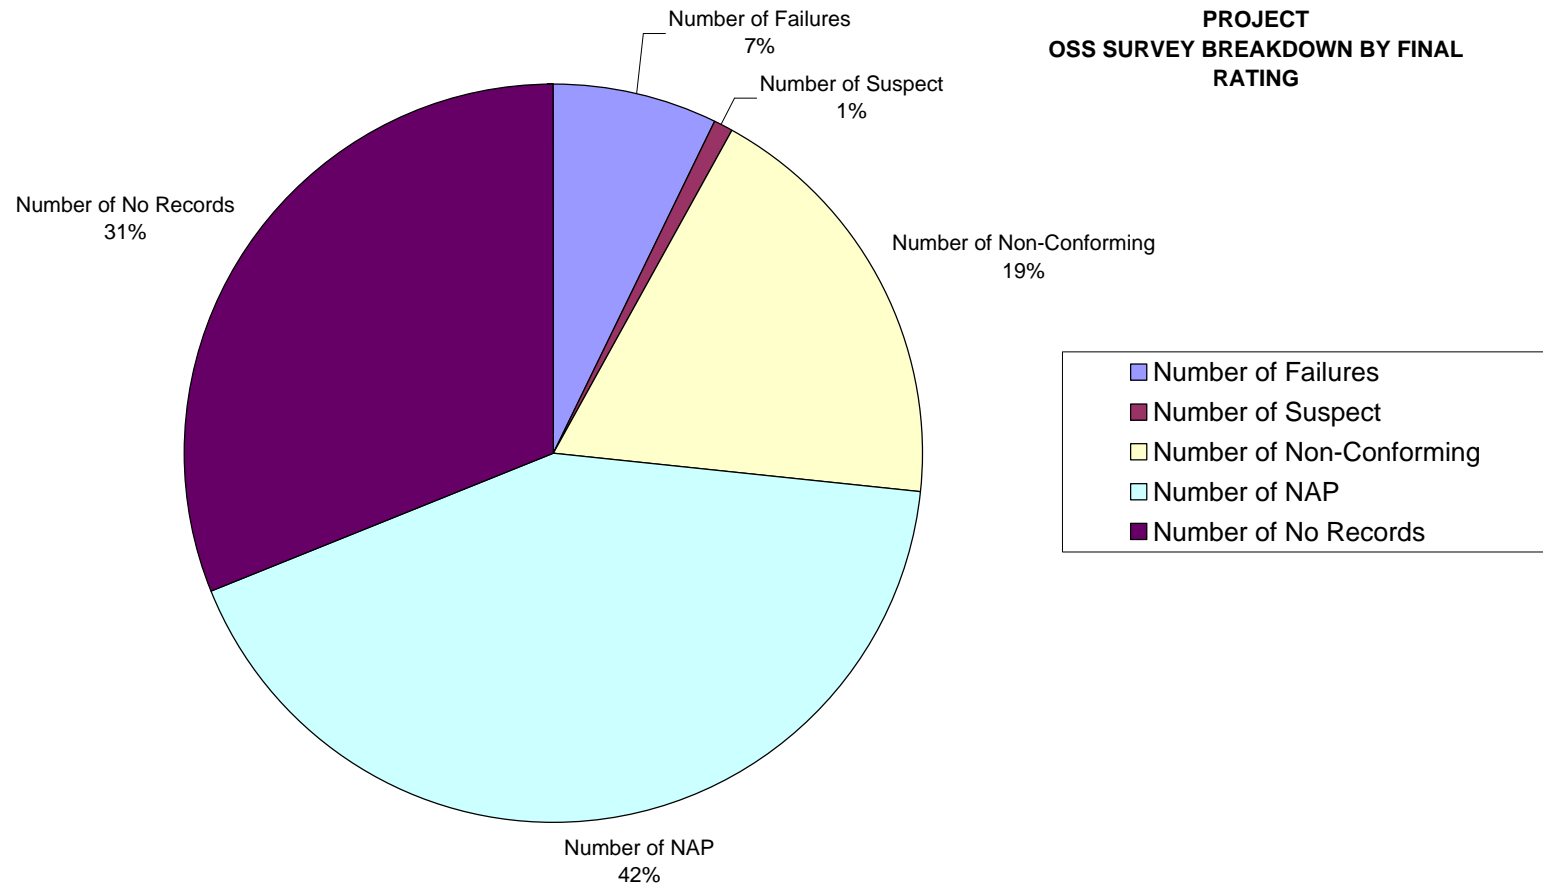
**FIGURE 3
DOGFISH CREEK RESTORATION
PROJECT
OSS SURVEY BREAKDOWN BY FINAL
RATING**

- A project total of **8 OSS failures (7%)** were found. A descriptive list of the OSS failures is contained in **Appendix E**. The **7%** failure rate found in the Dogfish Creek basin is in the middle of the range of failure rates (3% - 16%) found in other areas of Kitsap County surveyed by the Health District over the last twelve years.
- A project total of **1 suspect OSS (1%)** was found.
- A project total of **21 non-conforming OSS (19%)** were found.
- A project total of **35 OSS (31%)** with no records were found.
- A project total of **47 OSS (42%)** were rated as no apparent problems.

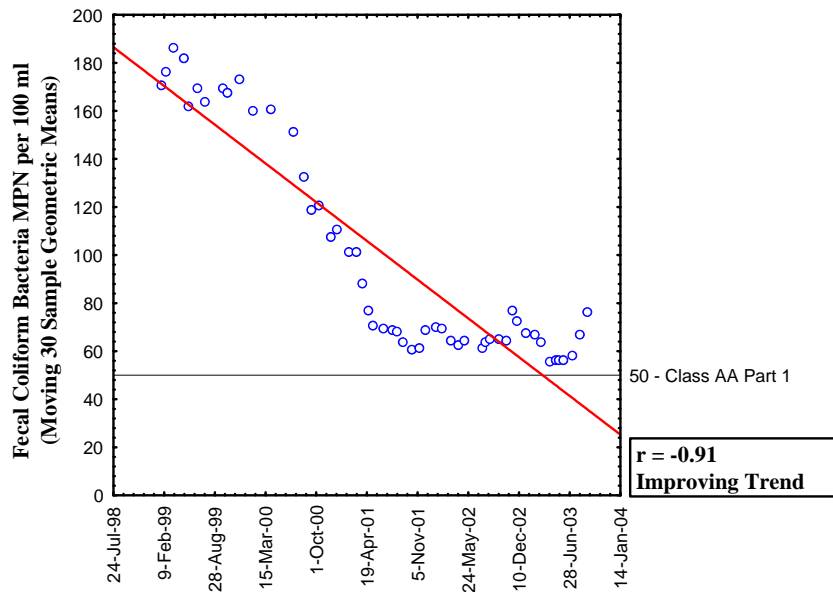
Figure 6
Fecal Coliform Bacteria Trend Analysis
South Fork Dogfish Creek (Station SF01), 1996-2003

In the South Fork (SF01), storm water was determined to be the primary source of FC contamination. Please see Section 6.3.4 for more information. Additional improvements in FC concentrations are expected after the City of Poulsbo completes implementation of recommendations outlined in the final report for the “City of Poulsbo Nonpoint Pollution Impacts to South Fork of Dogfish Creek” project.
